## HOME REPORT

116 Nethanvale/Auchlochan Lesmahagow  
Lanark  
ML11 0FX

## survey report on:

<b>Property Address:</b>	116 Nethanvale,Auchlochan Lesmahagow, Lanark, ML11 0FX
<b>Customer:</b>	MHA Auchlochan
<b>Customer Address:</b>	Auchlochan Garden Village, New Trows Road, Lesmahagow, ML11 0GS
<b>Prepared by:</b>	Whyte & Barrie/First Surveyors Scotland
<b>Inspection Date:</b>	07 October 2020

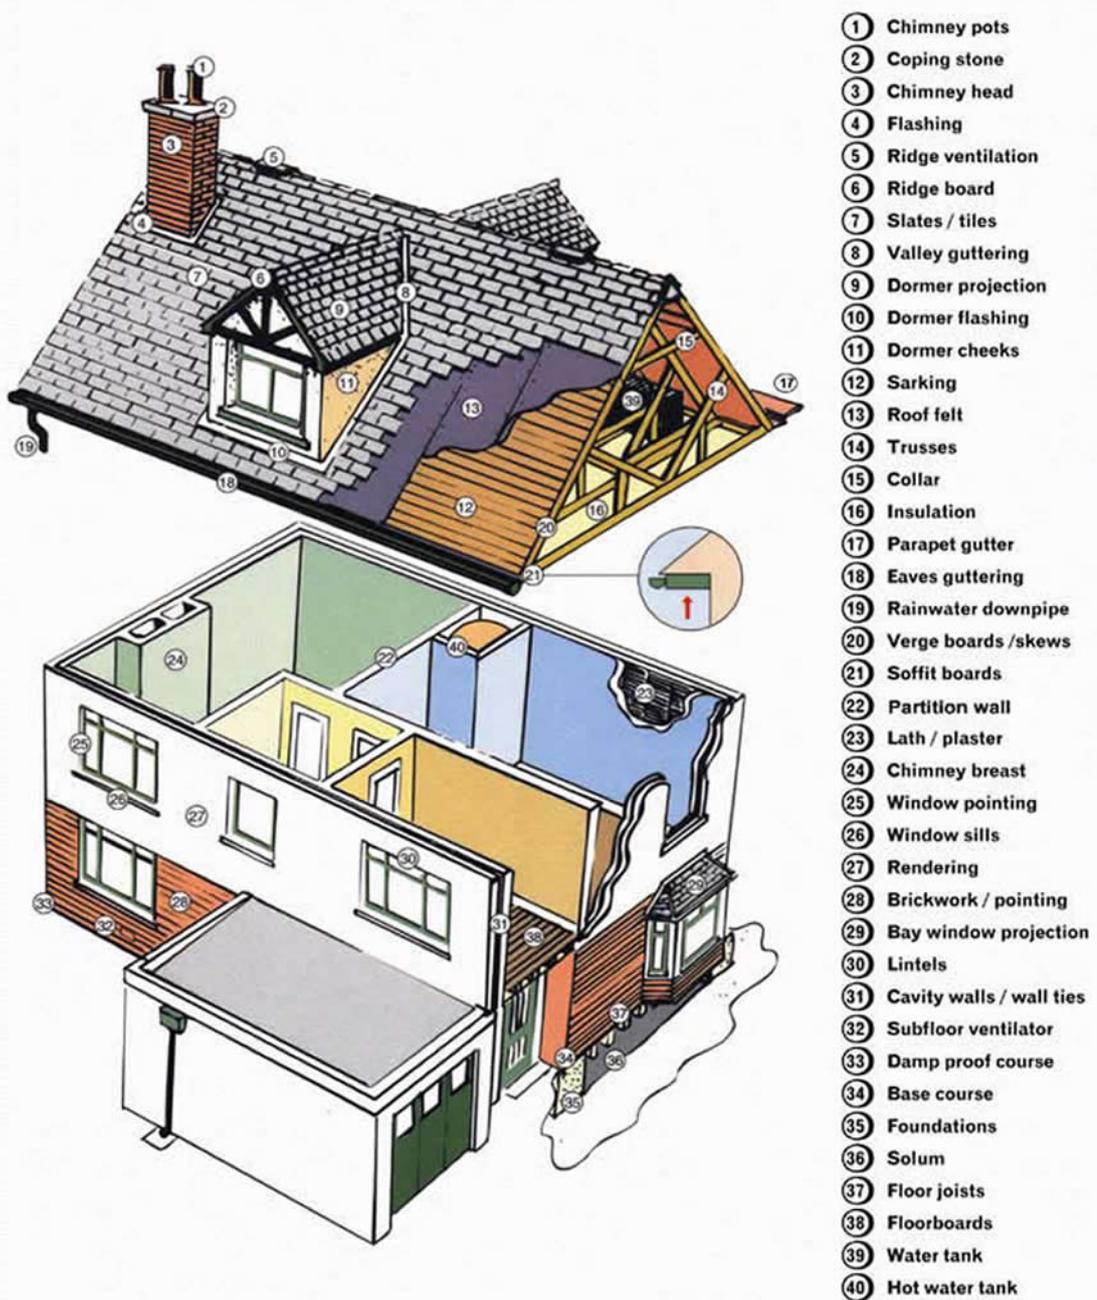
## Sectional Diagram showing elements of a typical house

Reference may be made in this report to some or all of the above component parts of the property. This diagram may assist you in locating and understanding these items.

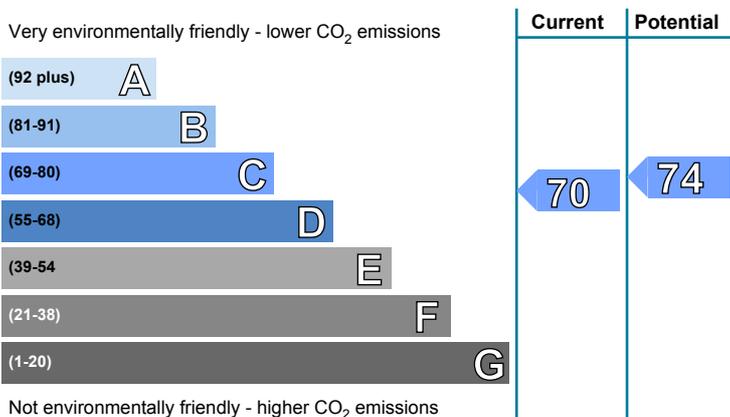
Your current rating is **band C (76)**. The average rating for EPCs in Scotland is **band D (61)**.

The potential rating shows the effect of undertaking all of the improvement measures listed within your recommendations report.
